# ESP32-S3 Series SoC

## Errata

This document describes known errata in ESP32-S3 series of SoCs.

Version 1.2  
Espressif Systems  
Copyright © 2023

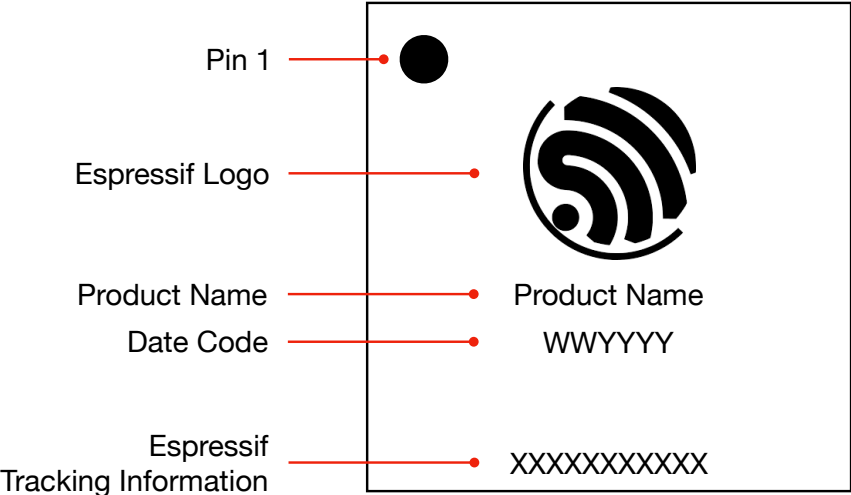
Figure 1: Chip Marking Diagram

- Espressif Tracking Information** line in chip marking

Table 2: Chip Revision Identification by Chip Marking

| Chip Revision | Espressif Tracking Information |
| v0.0 | xAXXXXXX |
| v0.1 | xBXXXXXX |
| v0.2 | xCXXXXXX |

In this case, the chip may be identified by **Date Code** in chip marking (see Figure 1). For more information, please refer to [Espressif Chip Packaging Information](#).

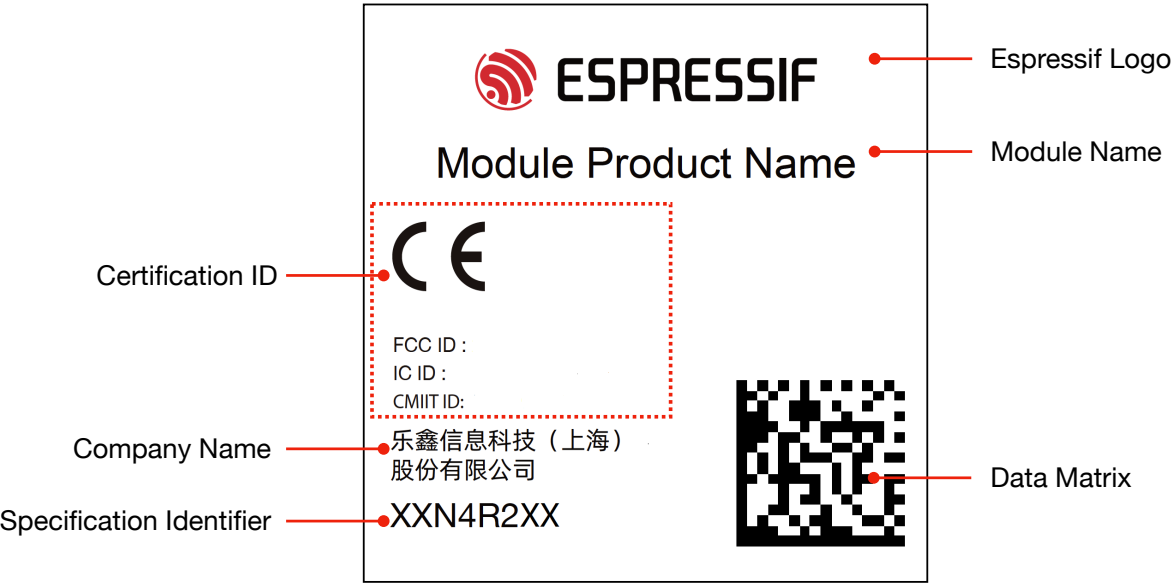
Figure 2: Module Marking Diagram

- **Specification Identifier** line in module marking

**Table 3: Chip Revision Identification by Module Marking**

| Chip Revision | Specification Identifier <sup>1</sup> |
| v0.0 | – |
| v0.1 | MOXXXX |
| v0.2 | MCXXXX |

<sup>1</sup> – means modules with this chip revision are not mass produced.
